Test Report Date: 03 Sep 2018 Page 1 of 4 No. NGBEC1804515702

The following sample(s) was/were submitted and identified on behalf of the clients as: Bi-metallic Lug

Model No.: DIN46329

Conclusion: Based on the performed tests on selected part of submitted sample(s), the results

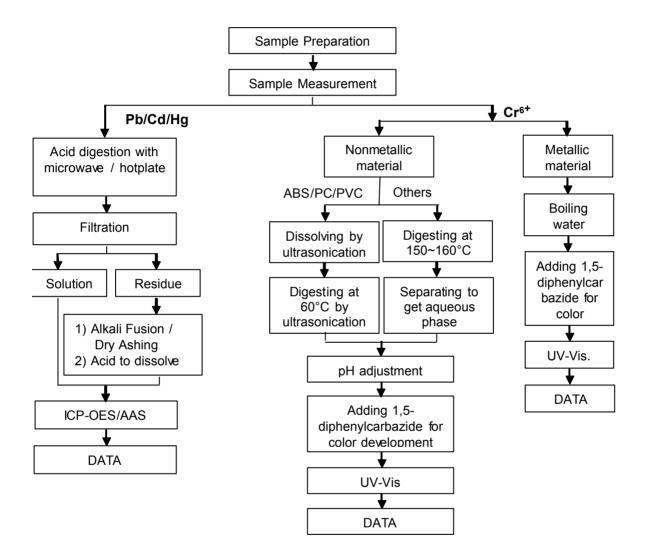
Pb/Cd/Hg/Cr6+ Testing Flow Chart

These samples were dissolved totally by pre -conditioning method according to below flow chart. (Cr⁶⁺ test method excluded)

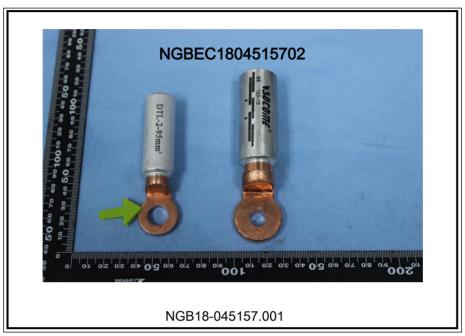
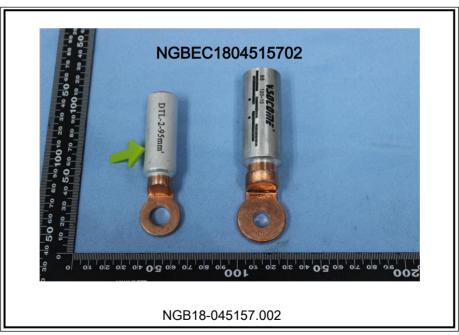
Sample photo:

Specimen No.	SGS Sample ID	Description
SN1	NGB18-045157.001	Orange metal part
SN2	NGB18-045157.002	Silvery metal part
